## PRODUCTION DELAYED

**Report Number:** 98-362B

Where: Granulation plant

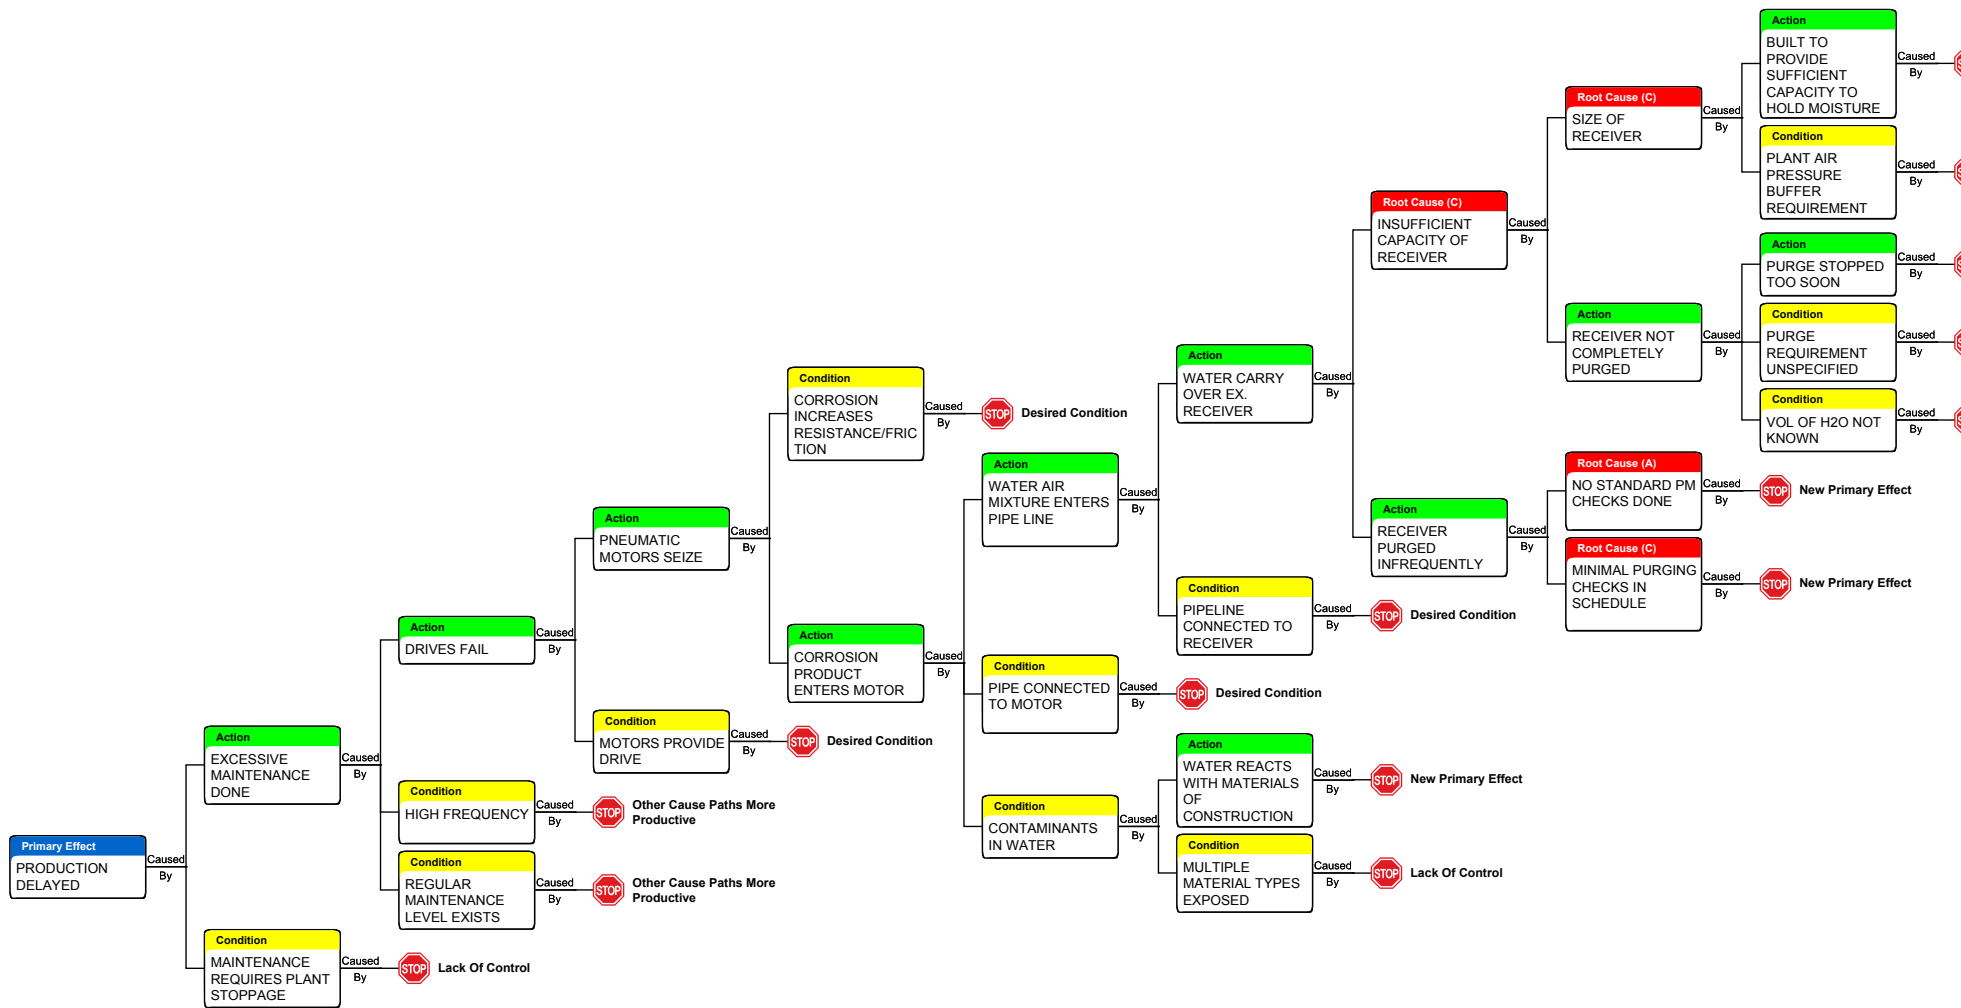
1. Realitychart Status: The Realitychart is in draft form and the Incident Report for the first stage of the investigation has been finalized.
2. Check the size and capacity of Motor and if applicable recommend change motor to hydraulic system
3. Some supposed causes have been purposefully left off the chart because there was contrary evidence.
4. Rules Check Status: Missing Causes Resolved.
5. Rules Check Status: Conjunctions Resolved.

1. RCA Team at 25-06-2015
2. Occurring every time motor stops
3. Found when opening up of Motor
4. From pipe and pneumatic hose connected to motor
5. Occurs every time motors stops
6. Electricians and operators confirm In time corrosion develops due to presence of water/air
