TRAIN SEPARATIONS

Report Date: 12-01-2014

Report Number: NC20150708

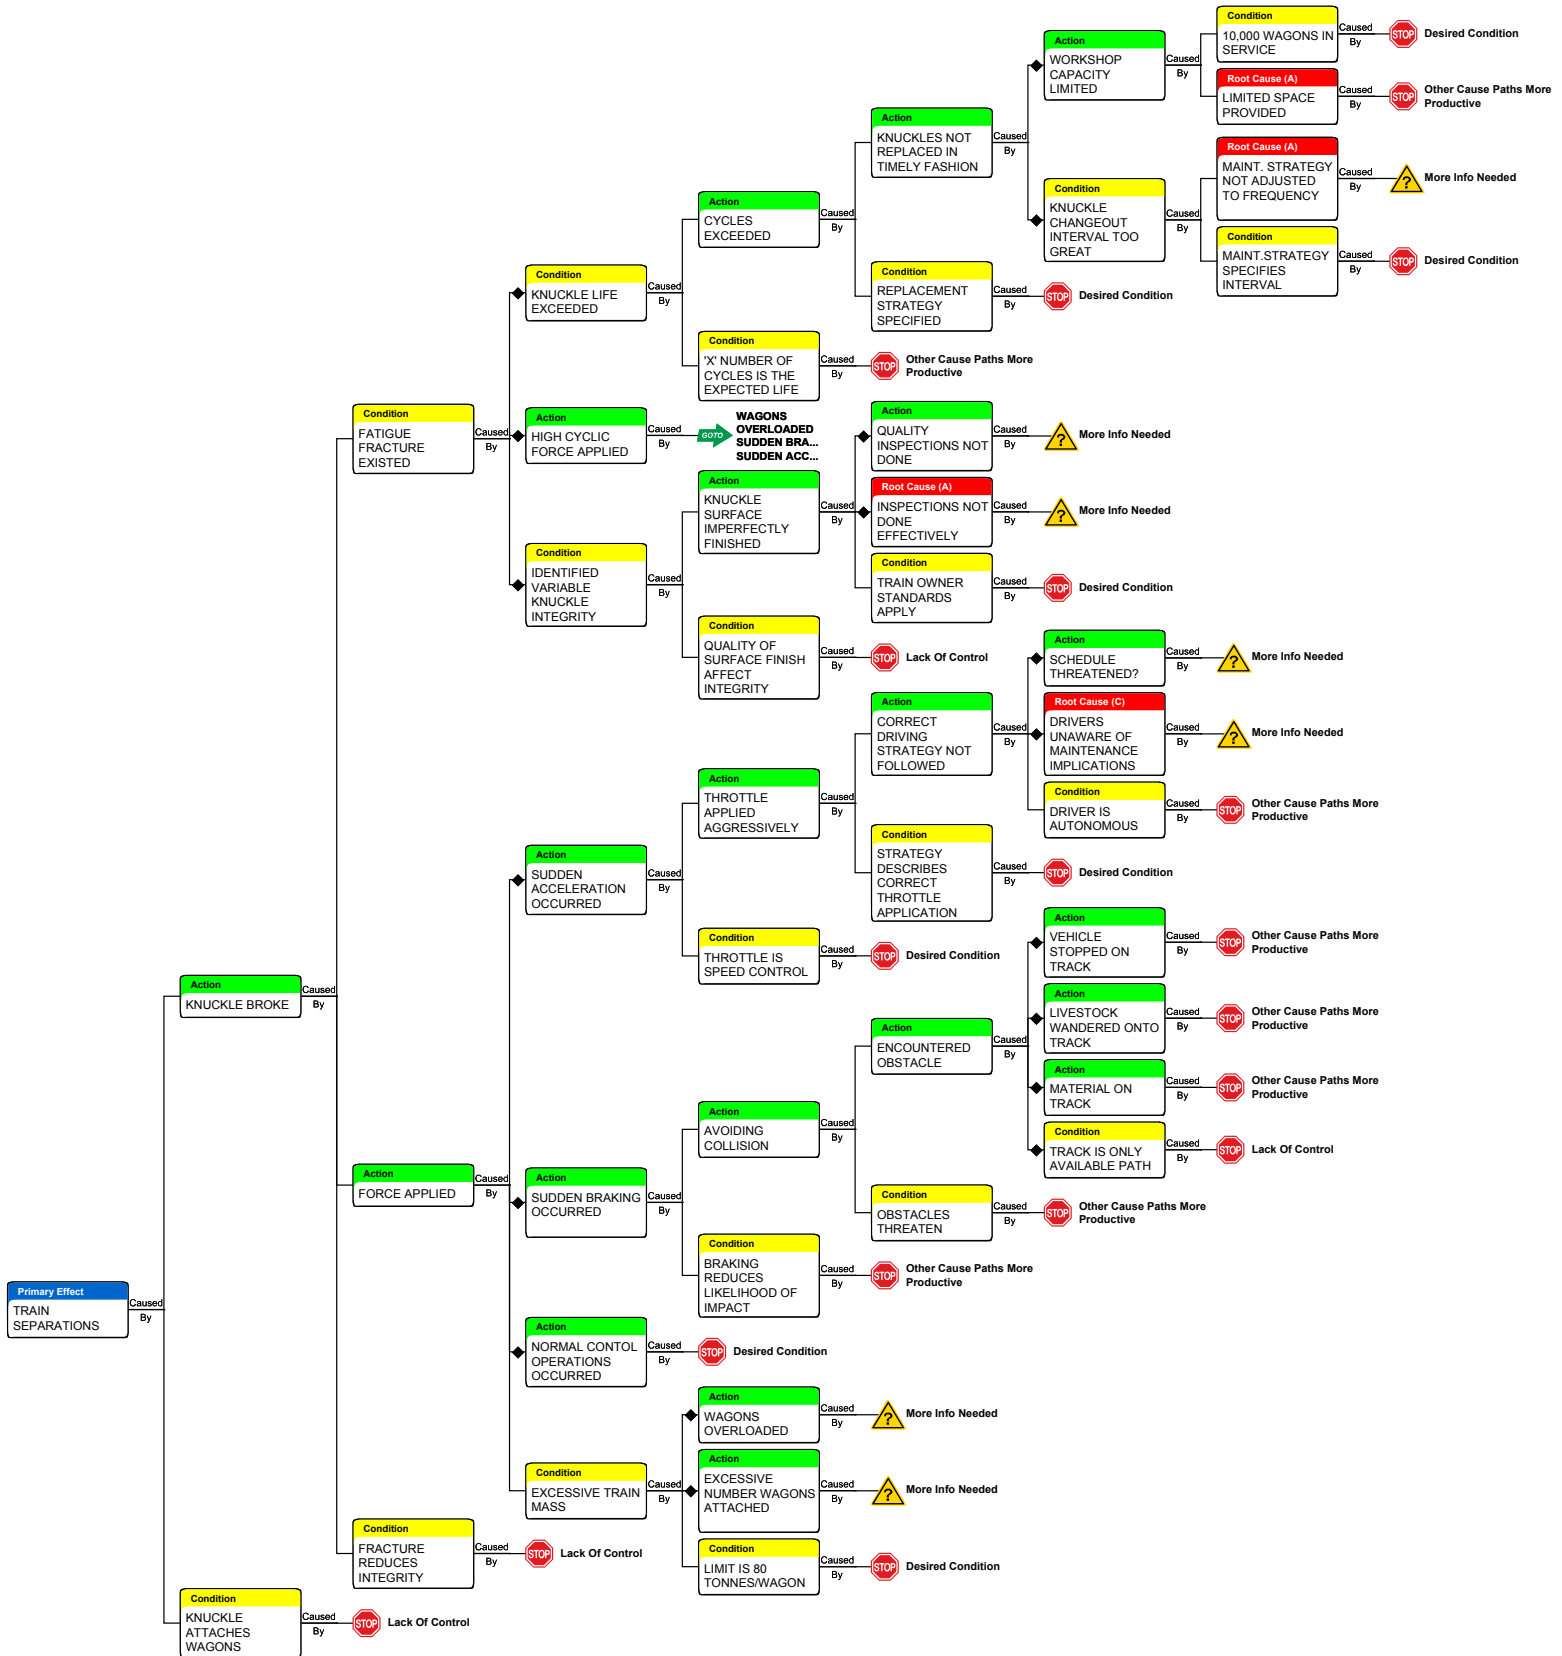
Train separations are being caused when the critical attachment between train wagons called a knuckle breaks. The investigation, which is continuing, revealed that the knuckles break because a fatigue fracture exists and is placed under stress in further train operations. The fatigue fracture is caused by either excessive cyclic forces or the fact that the knuckle life was exceeded or the fact that the knuckles delivered for use are of variable quality or some combination of all three, depending upon the event. Some of the causes indicated in the chart have not yet been substantiated but are 'reasonable' suppositions.

1. Realitychart Status: The Realitychart is in draft form and the Incident Report has not been finalized.
2. Some cause phrases contain conjunctions and may not be clear, feel free to question them.
3. Rules Check Status: Conjunctions Resolved.
4. Rules Check Status: Some causes have been purposefully left off the Realitychart.
